August 25, 2017

Re: Notice of Site Visit Findings and Proposed Actions Pursuant to Sections 301(a) and 402 of the Clean Water Act: 2015 MSGP Tracking Number PRR053093

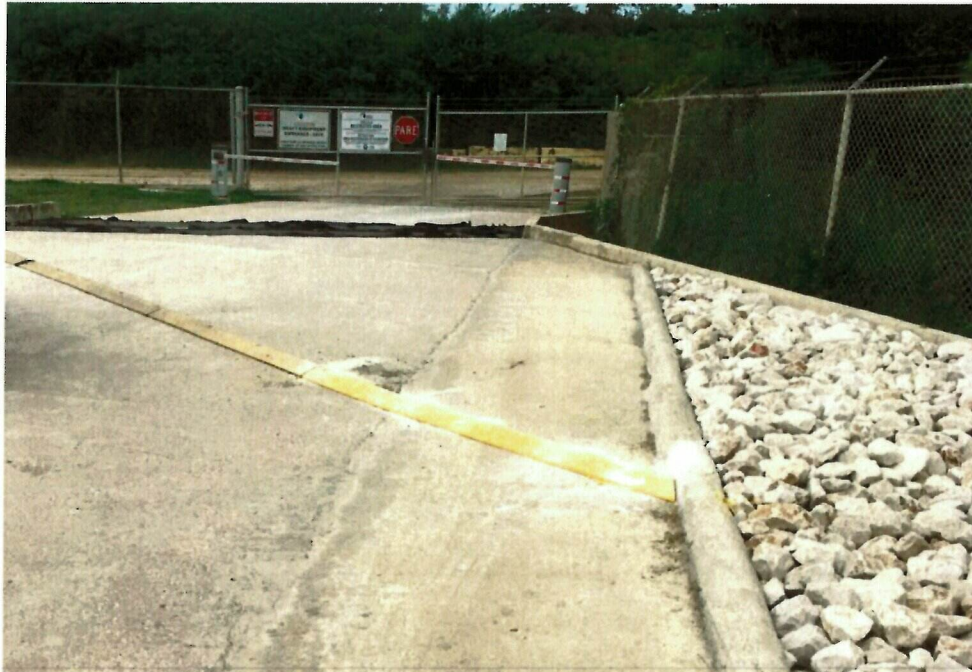
Picture 1

- A rain event took place during the walkthrough at the Agremax pile area and outfall 002

- The iron discharge concentration through storm water outfall 002 continues to be greater than the benchmark value established in Part 8.O.1 of the MSGP.

- The storm water runoff reaching outfall 002 had the same color as Agremax.

AES-PR Response: AES-PR disagrees with this finding. No storm water runoff was observed at outfall 002 during the walkthrough. AES-PR is not aware that a sample of the storm water runoff reaching outfall 002 was taken and analyzed to make this determination.

Moreover, based on its review, AES-PR installed a speed bump segment since the walkthrough inspection that diverts stormwater flow to vegetated areas on the AES-PR property. As a further immediate action, AES-PR has cleaned the access road to further reduce the constituents that could get carried by stormwater runoff.

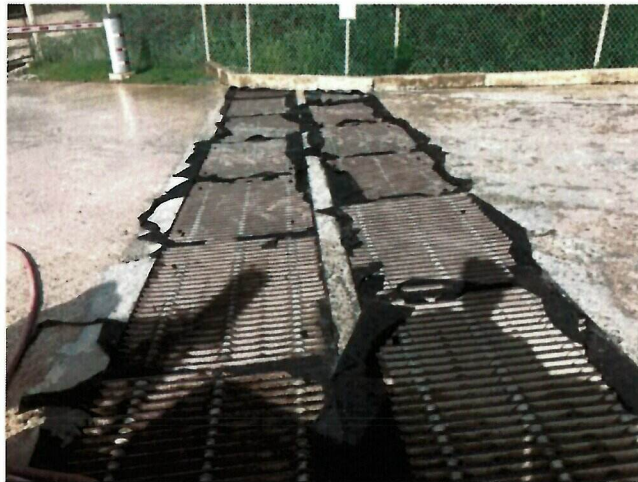
Picture 2

- The filter fabric installed at the metal bar grate near outfall 002 was observed with significant accumulation of solids and deteriorated.

AES-PR Response: Sediment is expected to accumulate in this sediment control practice which is cleaned periodically. The observed accumulation of solids in the filter fabric or its frayed exterior edge did not hamper the ability of this control to perform as designed.

At the time of the walkthrough, none of the filters had an excess of 6 inches of sediment accumulation as per the manufacturer's instruction (See Attachment 1).

AES-PR Response: The catch basin where the filter fabric - based best management practice is installed, is already cleaned periodically in accordance with AES-PR's SWPPP.

AES-PR Response: The filter fabric of this best management practice is replaced periodically if its interception surface is breached. After the inspection walkthrough, AES-PR replaced all fabrics filters.

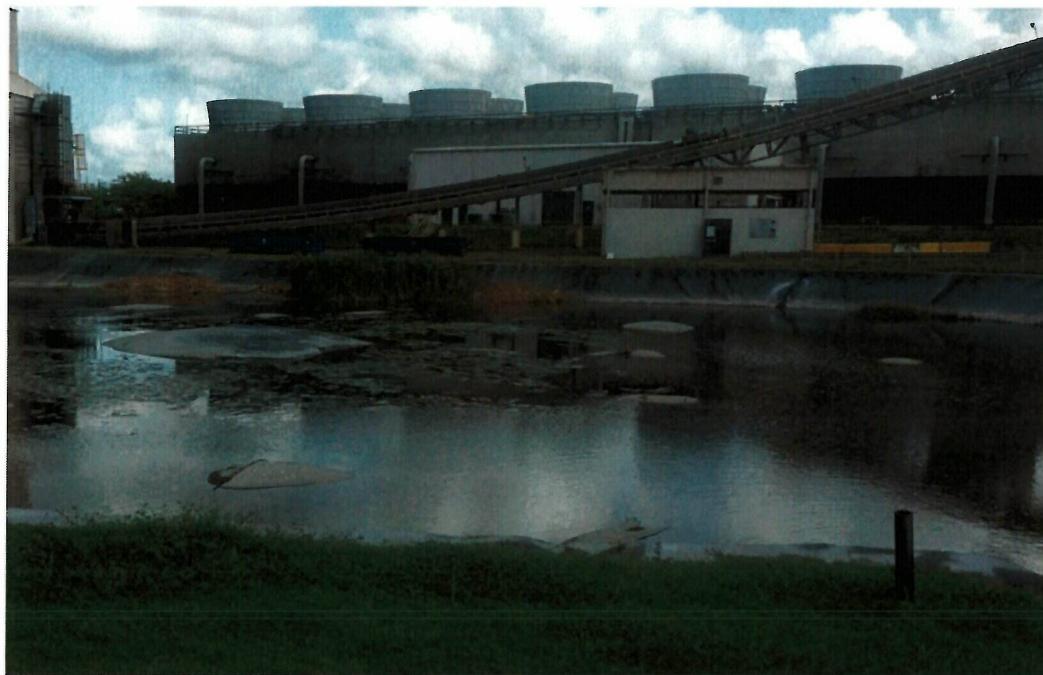
Picture 3

- The storm water pond was not properly maintained, and was covered with significant vegetation growth.

AES-PR Response: The storm water pond is properly maintained. The pond is inspected regularly and cleaned when necessary.

AES-PR Response: A small patch of emergent aquatic vegetation observed at the fringe of this pond has been partially removed. All observed vegetation will be removed from the Stormwater pond and that work should be finished in the next 10 days.

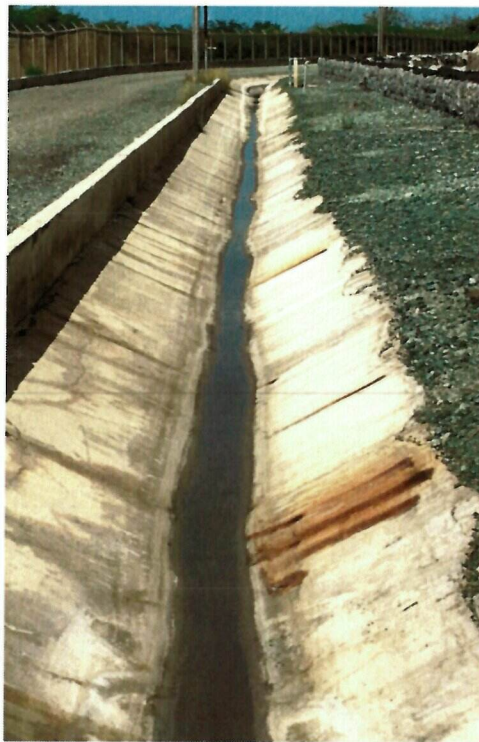
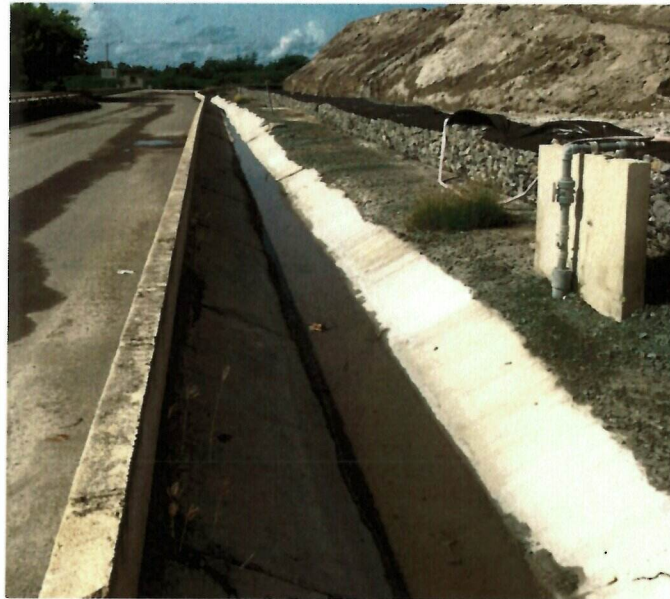
- A portion of the concrete storm water conveyance ditch located at the south side of the Agremax pile was observed covered with Agremax.

AES-PR Response: The ditch section was not "covered" with Agremax. This portion of the concrete storm water conveyance ditch contained Agremax that by design had been settled out of the storm water runoff from the Agremax stockpile that is carried by the conveyance. This is part of normal operations as further explained below.

AES-PR Response: The concrete storm water conveyance ditch has a secondary sediment retention function performed by in-stream check dams that pool the water and restrict flow to settle out suspended solids, and therefore an accumulation of sediment in the ditch is expected as part of its routine operation. This ditch is cleaned periodically when necessary, often at the end of the work shift. The sediment accumulation observed during the walkthrough was cleaned in accordance with our customary practice.

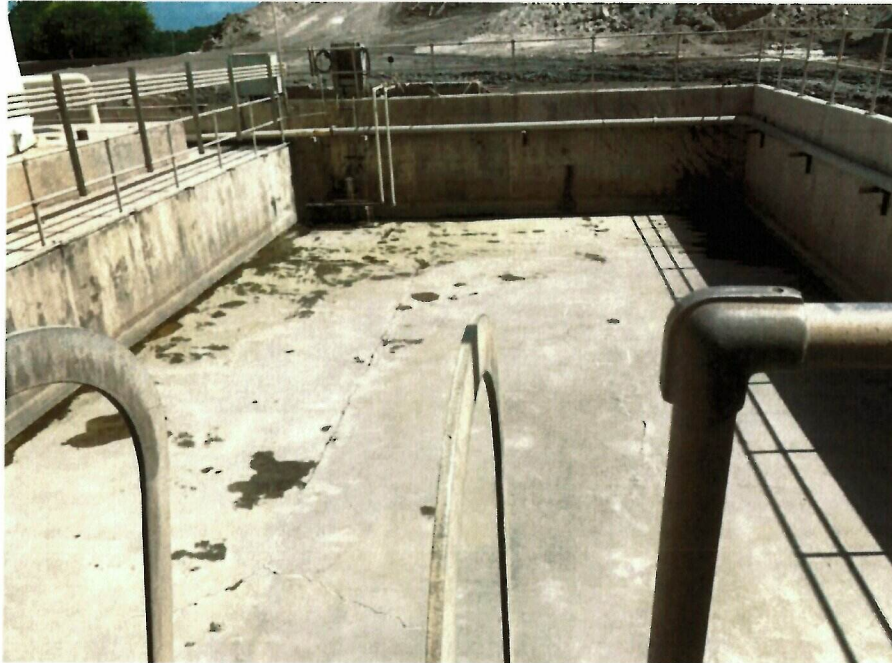
Picture 6

- *The diesel spill control tank had a discolored water accumulation and floating material.*

AES-PR Response: Direct rainfall, rainwater from the diesel fuel tank and tank truck unloading area secondary containment area and wind-blown material accumulate periodically in this below ground level tank.

AES-PR Response: The diesel spill control tank was emptied and cleaned. This tank is emptied and cleaned periodically to ensure that adequate spill retention capacity is available. The observed water accumulation and floating material did not hamper the tank's ability to work as designed.

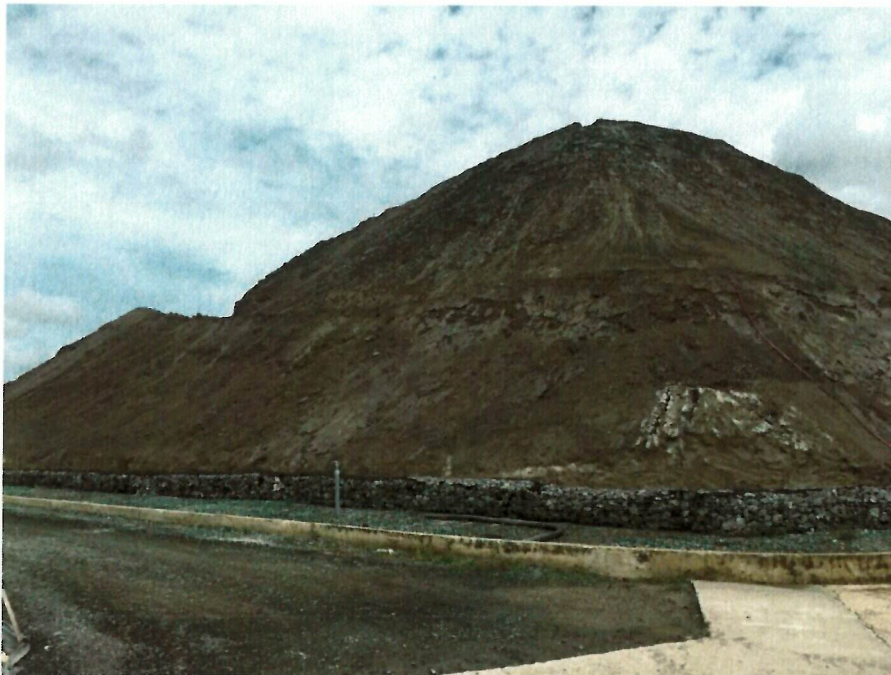
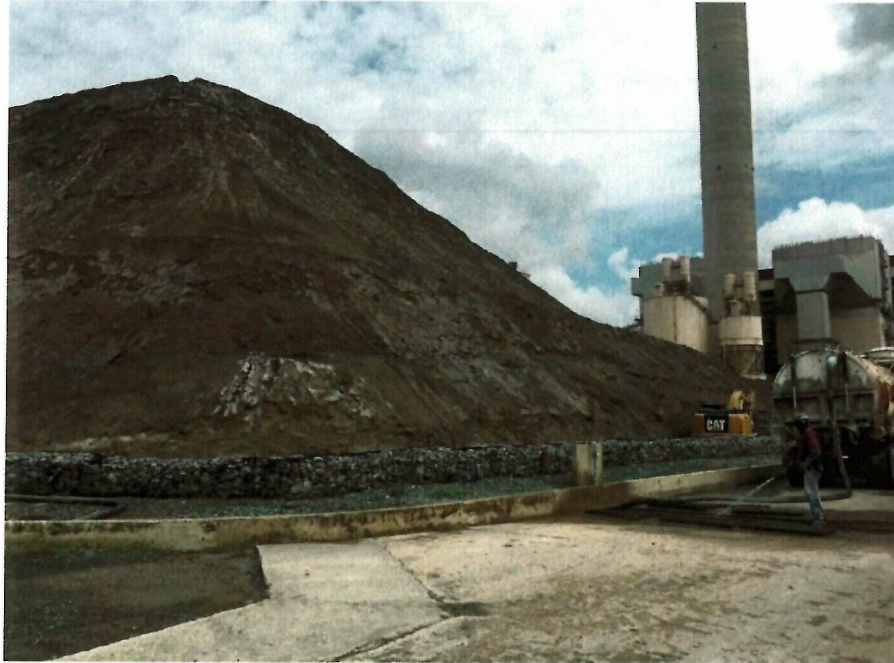
- The water sprinkler system for dust minimization at the Agremax pile was not in use.

AES-PR Response: AES-PR agrees that the sprinkler system was not in use at the time of the walkthrough. The sprinkler system is fully operational and was at the time of the inspection. Dust control water is applied daily to all areas of the Agremax stockpile.

- Certain areas of the Agremax pile were dry and without dust control water application.

AES-PR Response: Dust control water is applied daily to all areas of the Agremax stockpile. Moreover, after it dries, the Agremax surface develops a protective crust that prevents the formation of fugitive dust unless the integrity of the protective crust is breached by mechanical means.

AES-PR Response: AES-PR is operating in conformance with the Dust Control Plan and SWPPP for the Facility. For operational reasons, the water sprinkler system is activated at specific times as described in the Dust Control Plan and the SWPPP. To cover exposed areas that the sprinkler system cannot reach, a water truck with water cannon is used. After it dries, the Agremax surface develops a protective crust that prevents the formation of fugitive dust unless the integrity of the protective crust is breached by mechanical means.

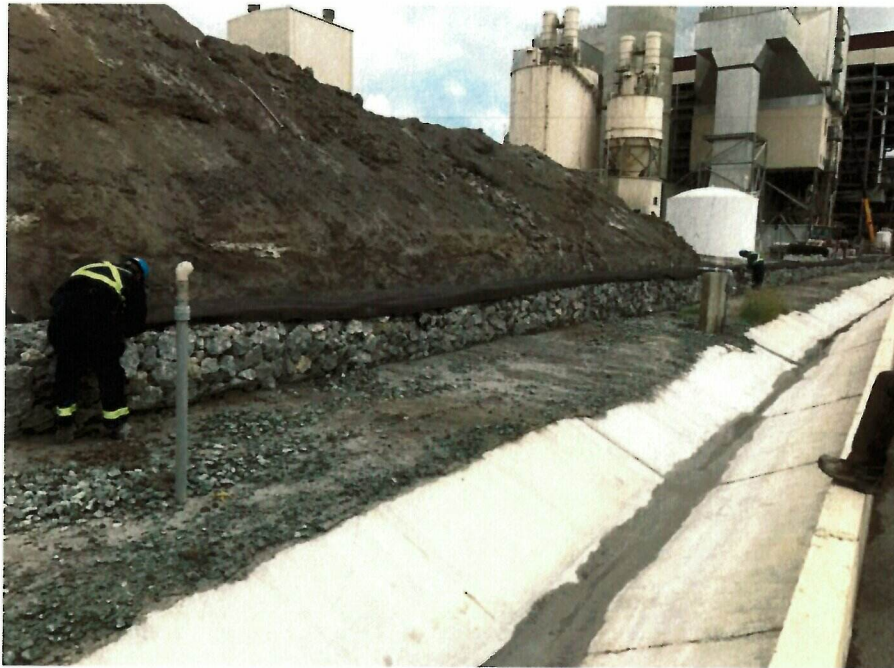
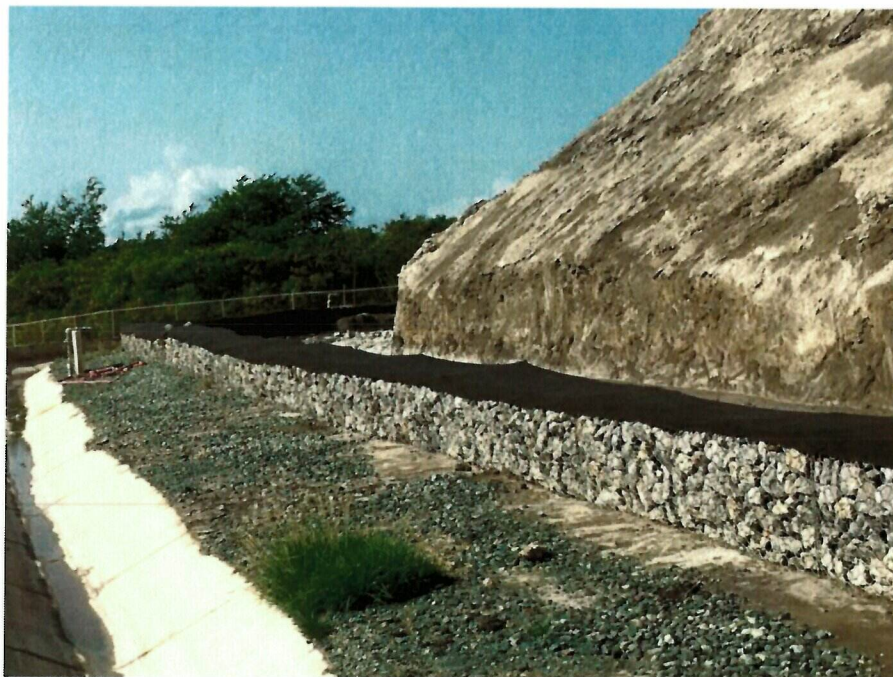
- *The gabion barrier filter fabric was in disrepair on the west side area of the Agremax pile. Agremax accumulation was observed in said gabion area, which reduces this best management practice capacity to filter storm water.*

AES-PR Response: AES-PR disagrees that the gabion barrier was in disrepair. The gabion barrier acts as primary sediment control. Some accumulation of Agremax in the buffer area is to be expected during normal operations.

AES-PR Response: The buffer zone between the toe of the Agremax stockpile and the gabion structure was cleared and the filter fabric on the gabion structure was replaced.
